A Case History of Port Mansfield Channel, Texas

GITI REPORT 12

May 1977

GENERAL INVESTIGATION OF TIDAL INLETS

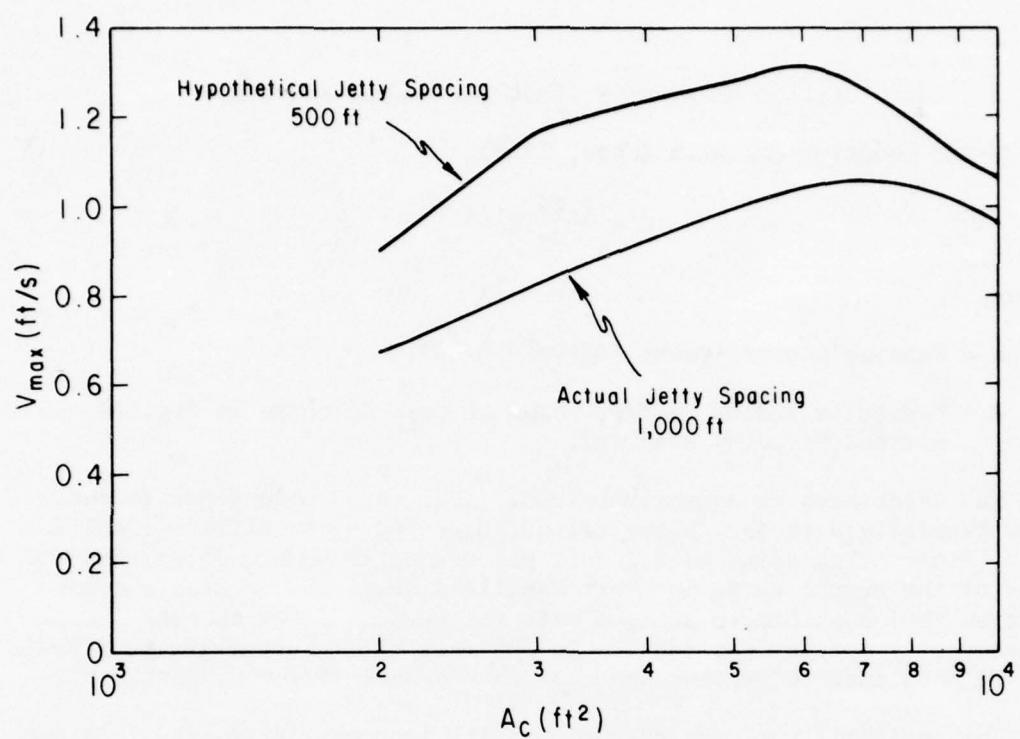
Figure 10 is a V_{max} versus A_C curve for Port Mansfield channel. K values were calculated from equation (1), using the values of the variables listed on page 23, but varying A_C , and substituting $(A_C/\text{jetty spacing})$ for the hydraulic radius, or in effect holding the channel width constant and varying the channel depth. The K values were used in Figure 7 to determine appropriate values of V_{max} . V_{max} values were then calculated using equation (2).

Figure 10. V_{max} versus A_C stability curve for Port Mansfield channel.

V_{cr} was calculated as approximately 3.2 feet (0.98 meter) per second. This generally agrees with the values suggested by Escoffier (1940) for V_{cr} . Since a V_{cr} value of 3.2 feet per second is much greater than the peak of the actual curve for Port Mansfield (Fig. 10), a stable cross section is impossible to achieve with the present jetty spacing. Even if the jetty spacing was reduced to 500 feet, sufficient velocities could not be developed to provide scour of the channel (Fig. 10, dashline).

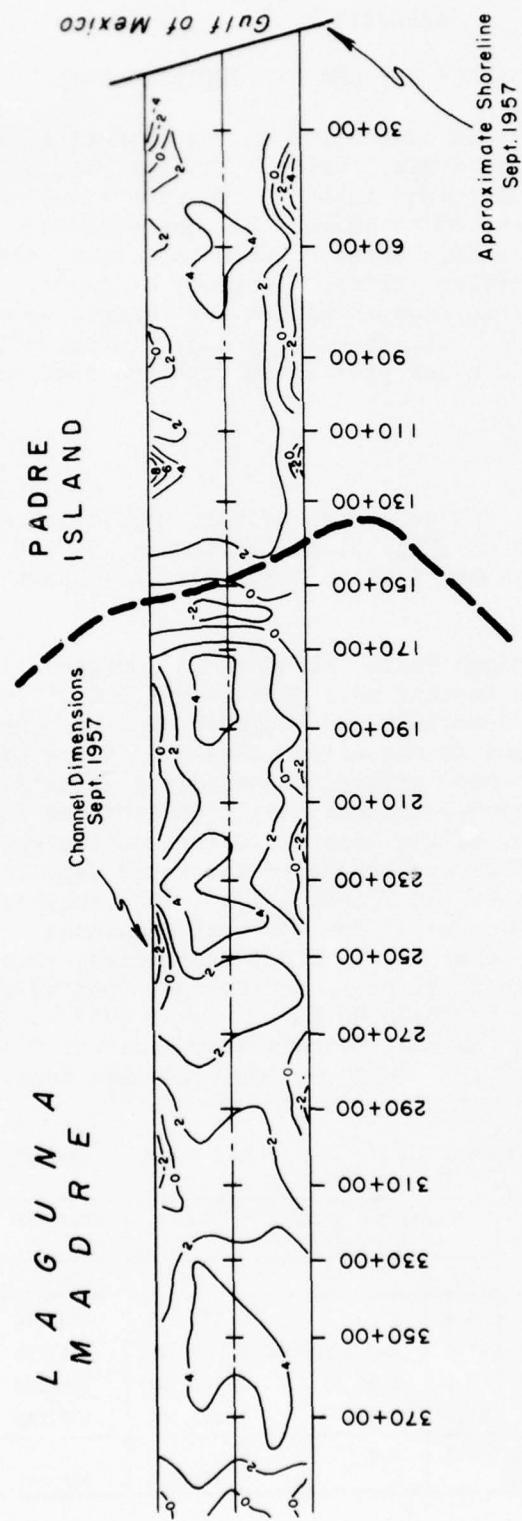
Figure E-1. Fill and scour map of Port Mansfield channel from September 1957 to June 1959.

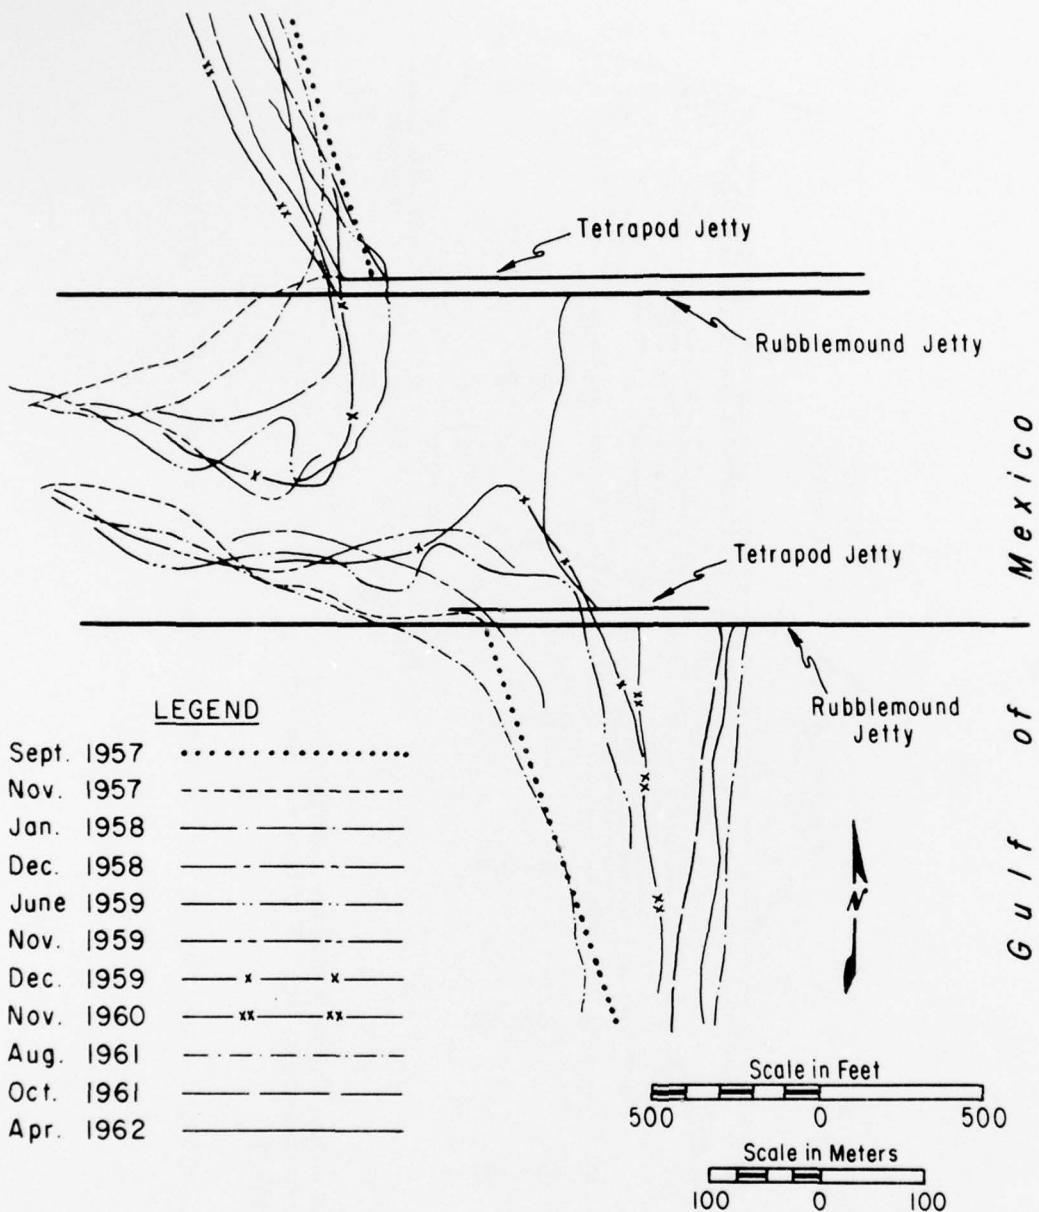
Figure E-2. Mean sea level shoreline surveys from September 1957 to April 1962.

After the period of severe recession, the beach south of the jetties accreted significantly through December 1959, with the mean sea level (MSL) contour advancing about 728 feet (221.89 meters) seaward along the south jetty. North of the inlet, the beach accreted from the January 1958 condition, with an advance of the MSL contour of generally less than 100 feet (30.5 meters).

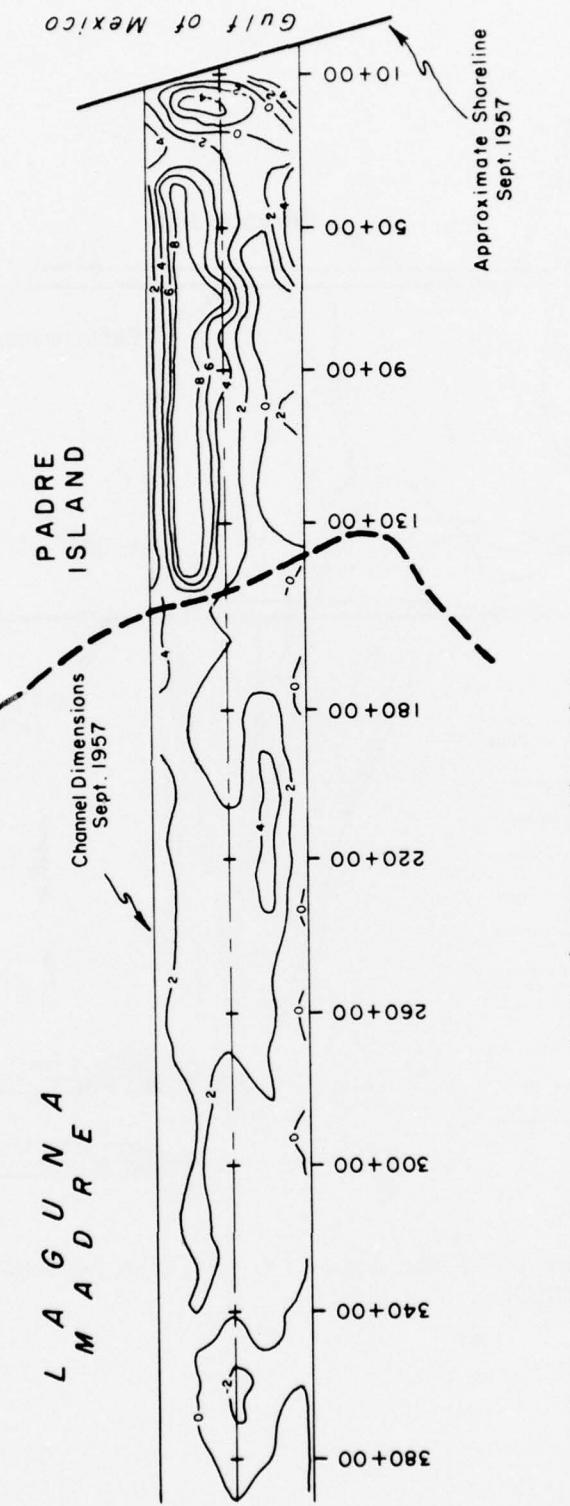
Figure E-3. Fill and scour map of Port Mansfield channel from June 1959 to April 1962.

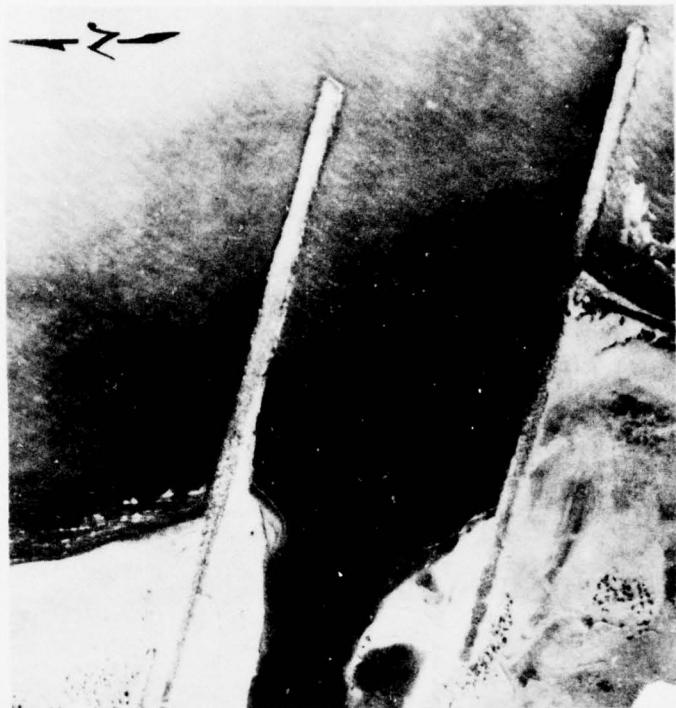
The entrance channel jetties and dredging of the channel were completed by May 1962; the postconstruction condition is shown in Figure E-5.

Figure E-5. Port Mansfield channel entrance,
January and July 1962.

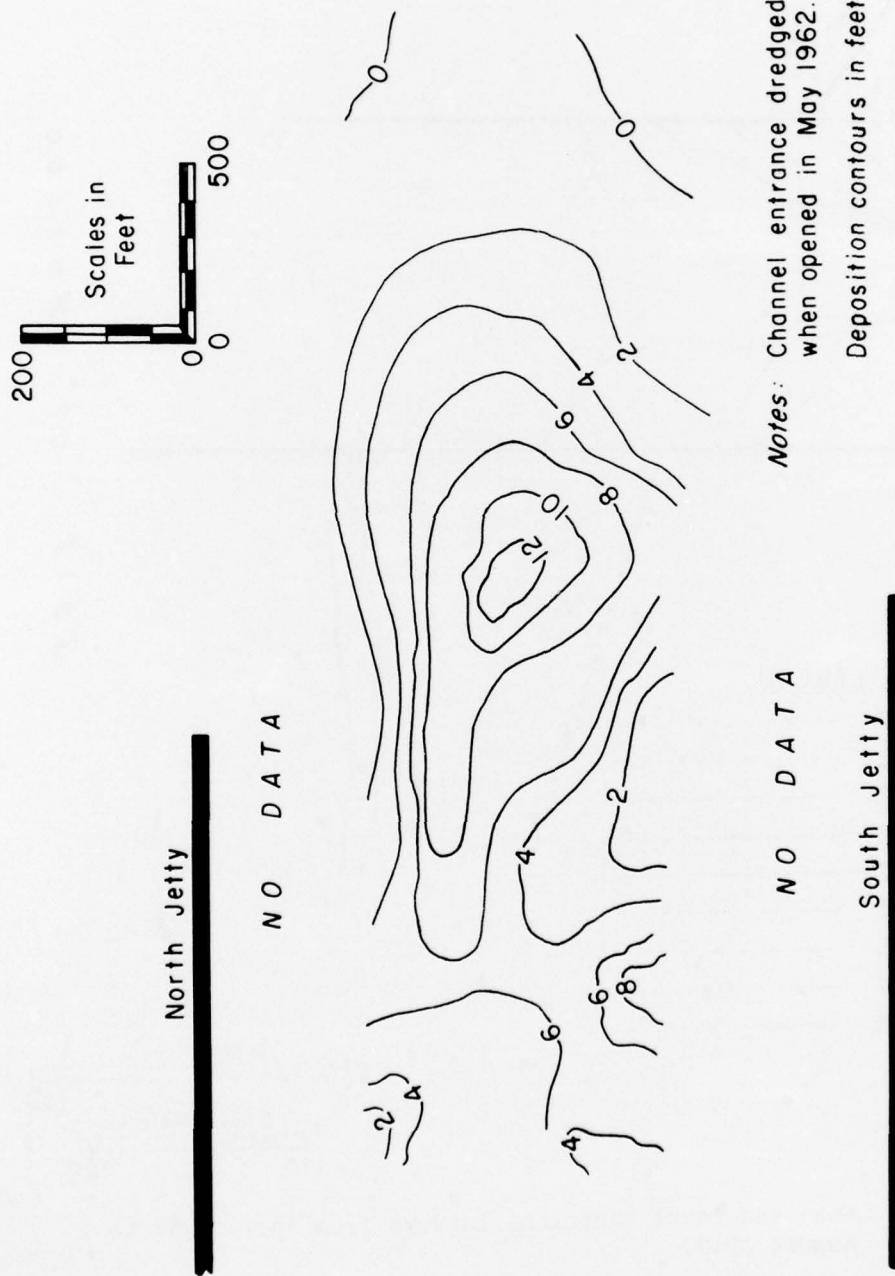
Figure E-6. Channel entrance deposition, May 1962 to February 1963.

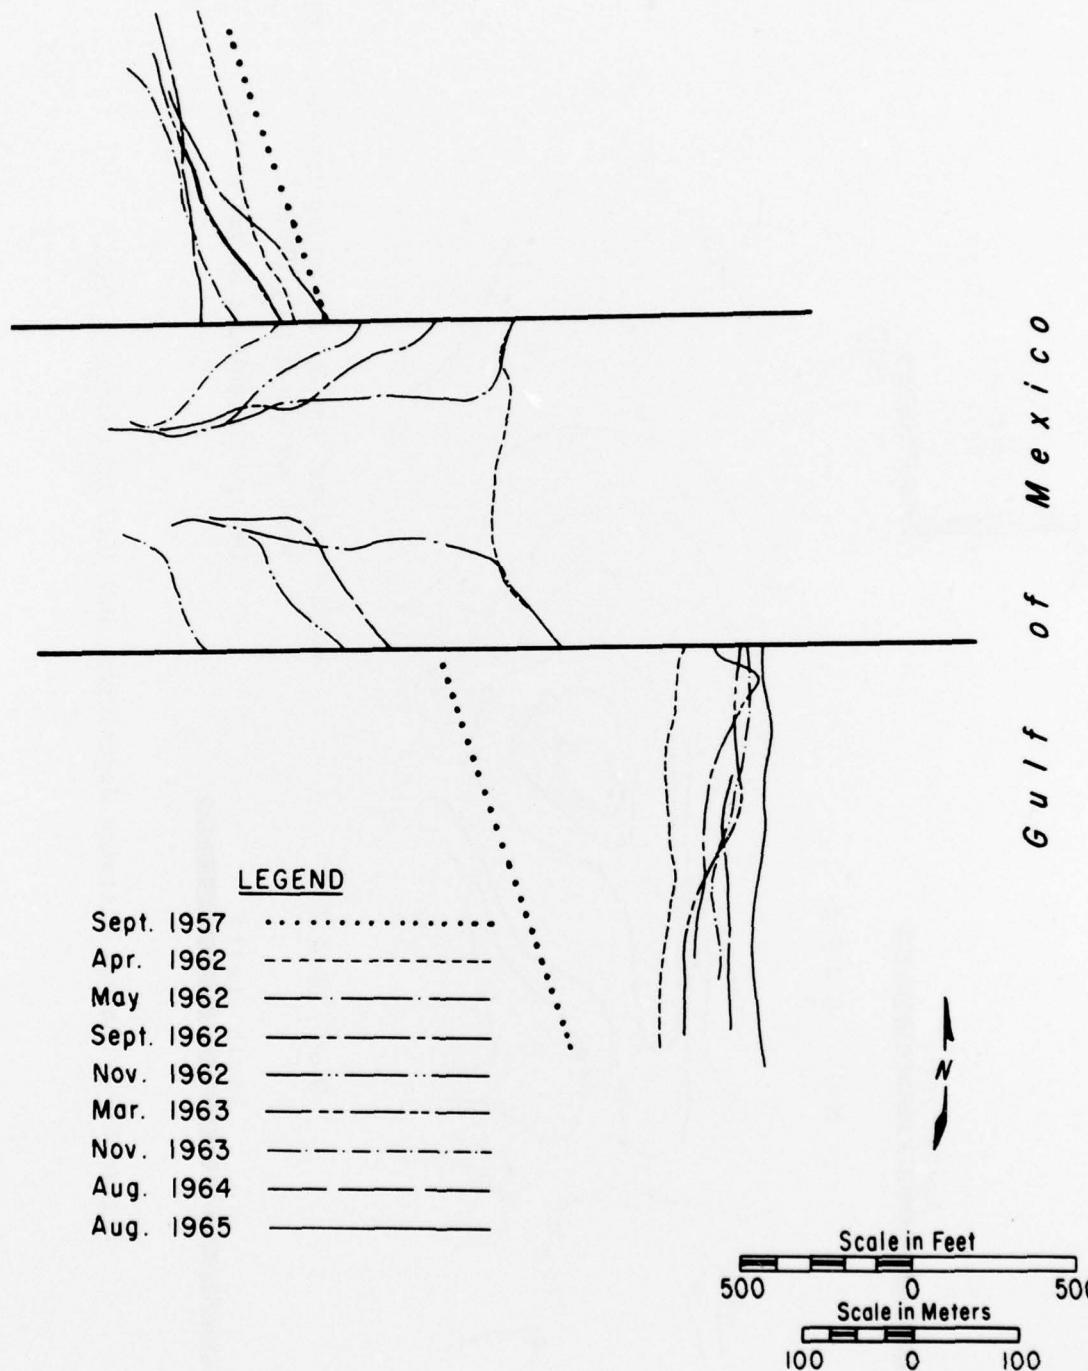
Figure E-7. Mean sea level shoreline surveys from April 1962 to August 1965.

Figure E-7 shows an advance of the MSL contour of approximately 240 feet (73.15 meters) along the outside of the south jetty between 1962 and 1965, and a general recession adjacent to the north jetty. The filllet south of the channel achieved approximate equilibrium conditions in the position of the MSL contour.

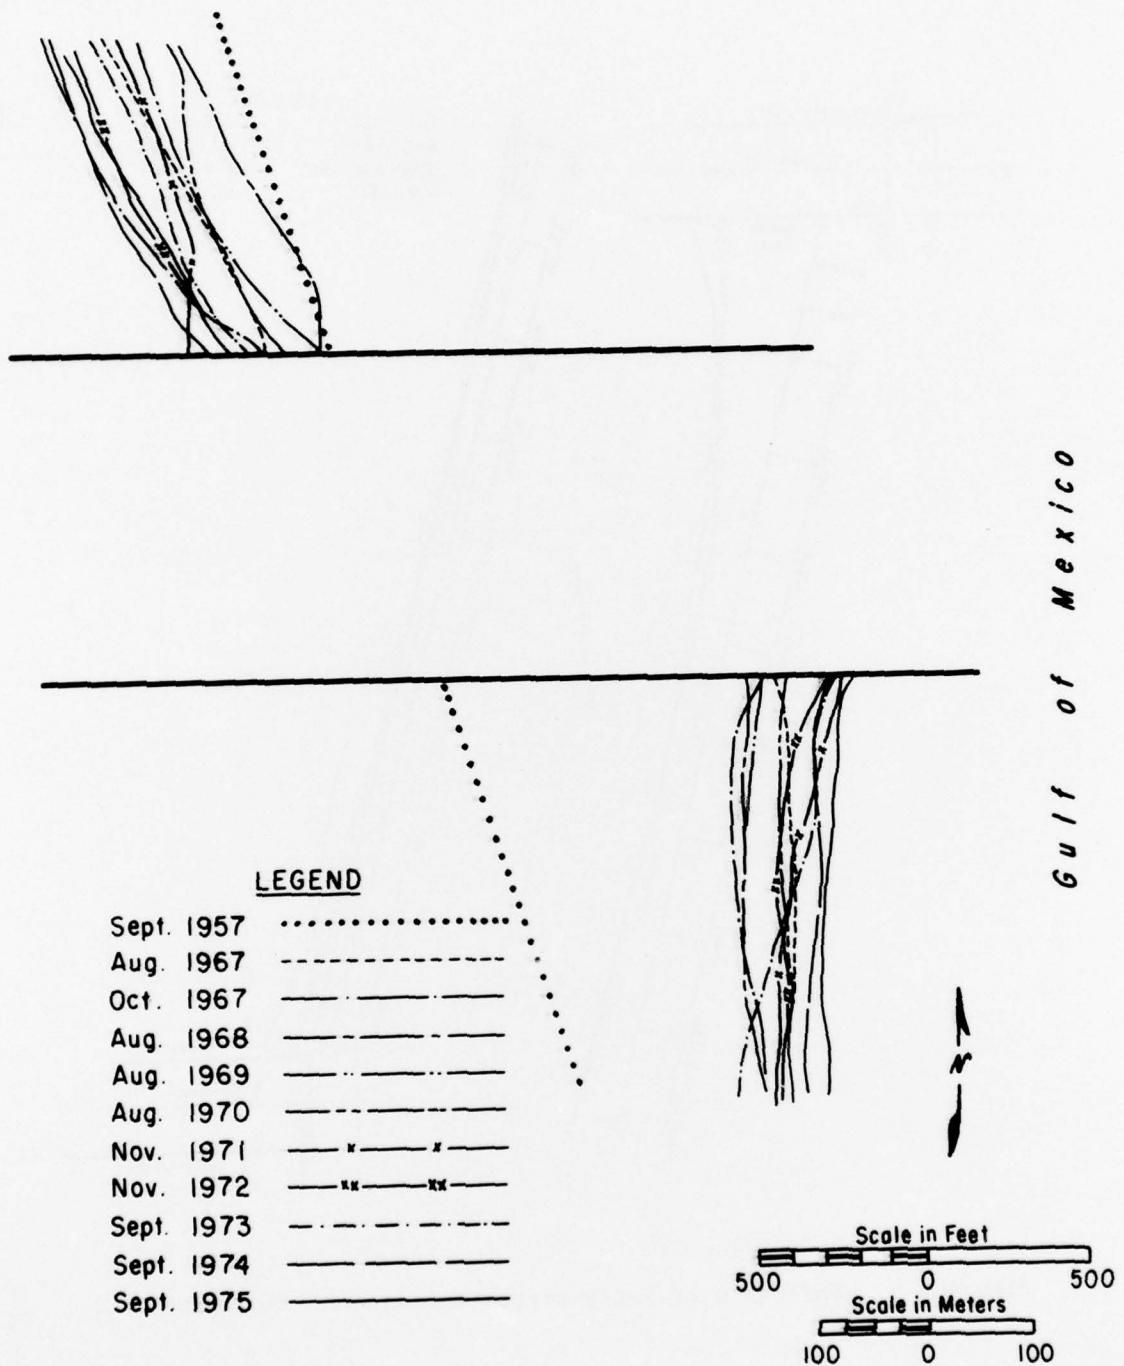
The annual shoreline changes from August 1967 to September 1975 are shown in Figure E-8. A general recession of the shoreline between August and October 1967 occurred; the north shoreline receded 200 feet (60.96 meters) and the south shoreline retreated about 100 feet (30.48 meters). These changes were caused by storm surge and waves and currents associated with the passage of Hurricane Beulah across the southern tip of Texas on 20 September 1967. Although the effect of Beulah on the channel itself was not quantitatively documented, strong ebb currents prevailed for several days afterward due to heavy rains in the interior. Therefore, considerable scour of the channel probably occurred.

Figure E-8. Mean sea level shoreline surveys from August 1967 to September 1975.

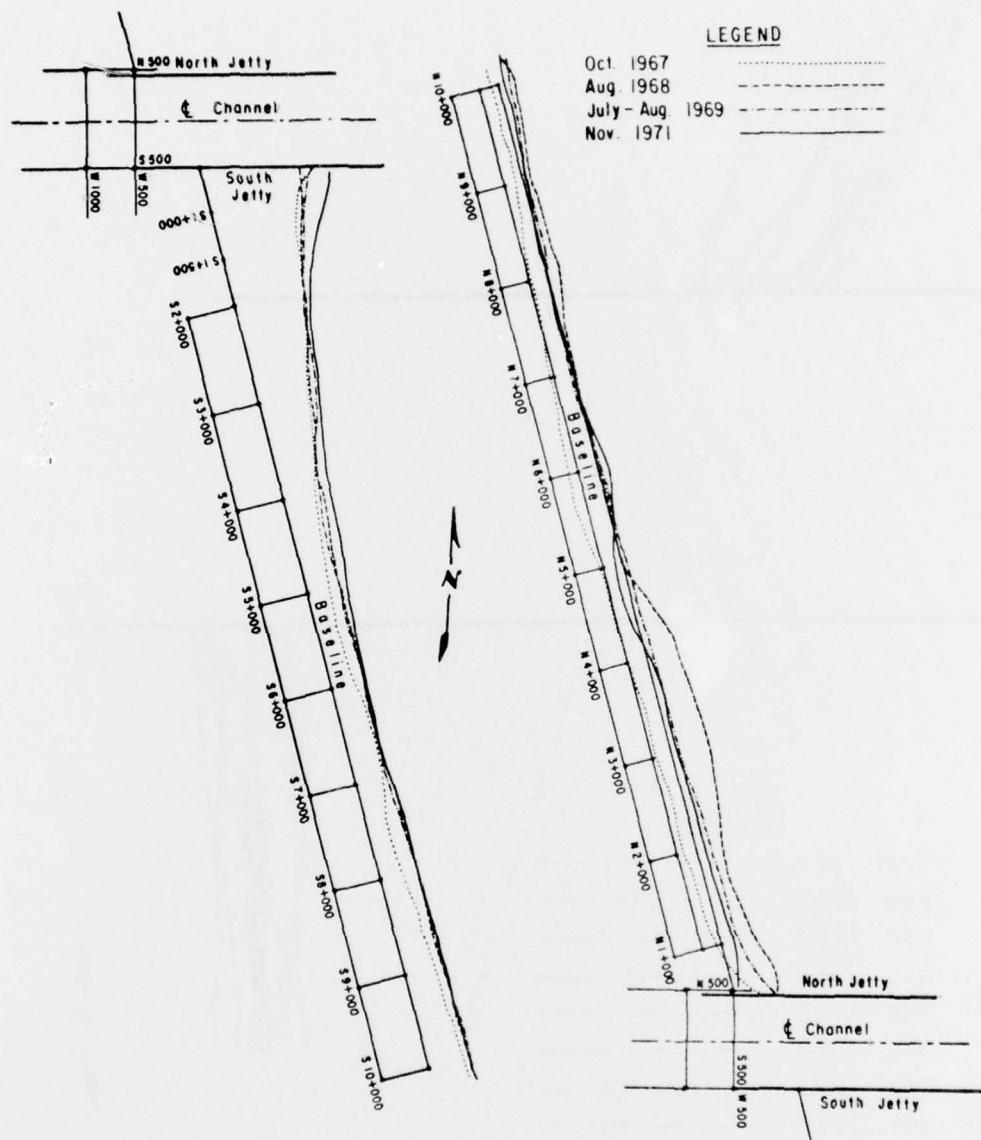
The influence of the jetty system on the shorelines adjacent to the inlet is shown in Figure E-9. Note that the same general trends in erosion and accretion occur over 9,000 feet (2,743 meters) from the channel on both the north and south beaches.

Figure E-9. Influence of jetty system on adjacent shorelines.
